BLACK MOUNTAIN RESERVOIR DAM
BUNCOMBE COUNTY, NORTH CAROLINA
NATIONAL INVENTORY NO. - NC 1247
STATE INVENTORY NO. 11-007-H

PHASE I INSPECTION REPORT
NATIONAL DAM SAFETY PROGRAM

GOLDER ASSOCIATES INC.

SEPTEMBER 1980

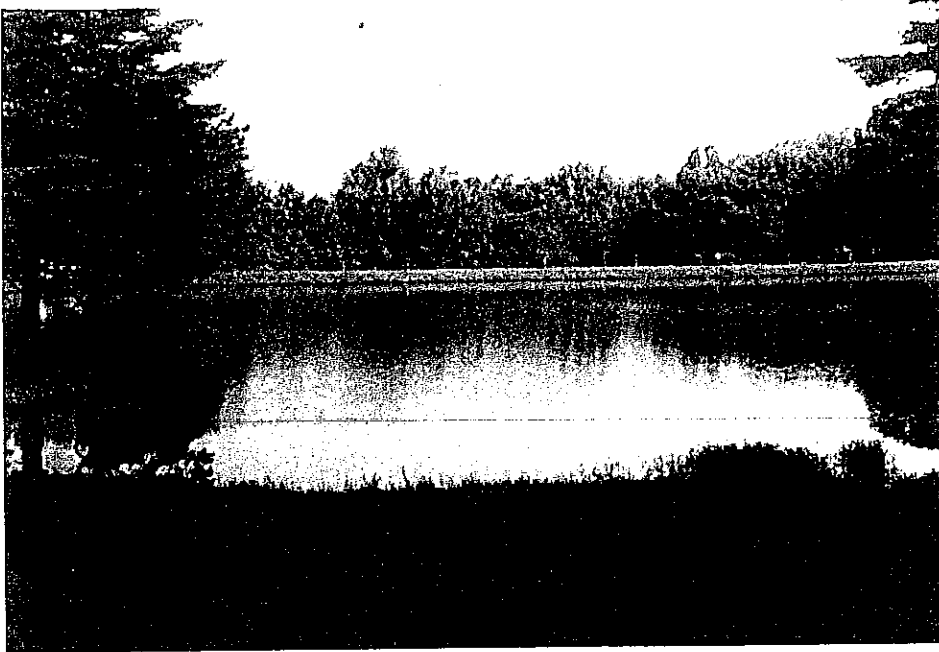
1. Black Mountain Reservoir and Dam

1. The dam is reasonably maintained with no undesirable growth (see Photos 2 and 3).
2. An access roadway crosses the crest and a fence is located on the downstream shoulder of the dam (see Photo 1).

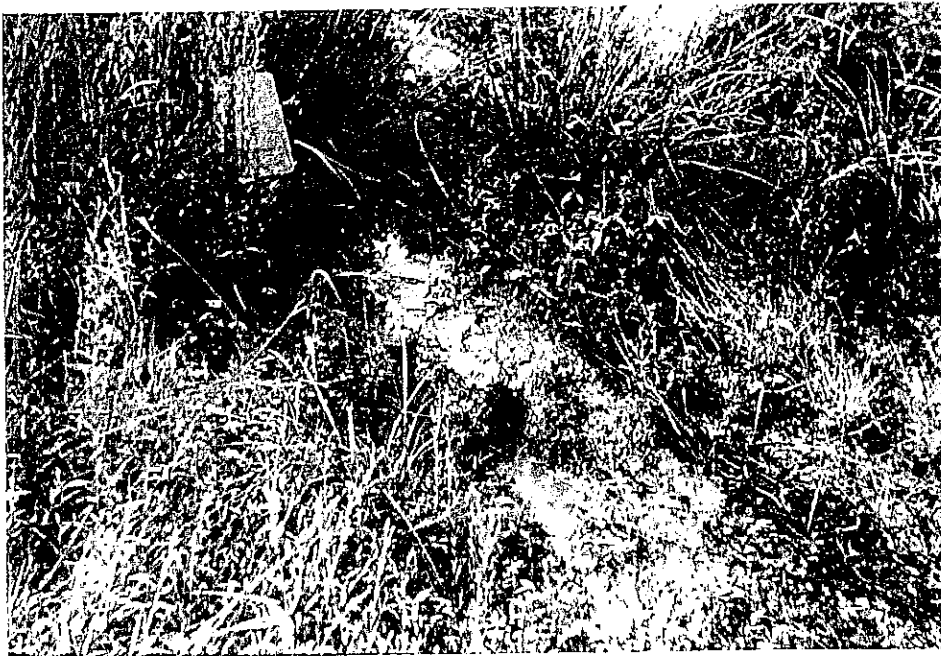
6. Seepage Near Toe of Dam

3. Several stones (max. 1 ft. dia.) were noted on the downstream slope, mostly on lower portion.
4. Heavy seepage across lower third of the downstream slope and at the toe was noted (see Photo 6). Total seepage flow is about 3 to 5 gpm. Rust colored floc was noted but no materials migration was observed.

The dam is reasonably maintained, however, it has heavy seepage and may have minor toe stability problems. The total seepage flow is estimated to be about 3-5 gpm. Rust colored floc was present but no material migration was noted. There appears to be a hazard to loss of life in the event of a failure of the dam.

The existing operation and maintenance procedures are adequate but the seepage flow rate and movement of the downstream slope should be monitored.

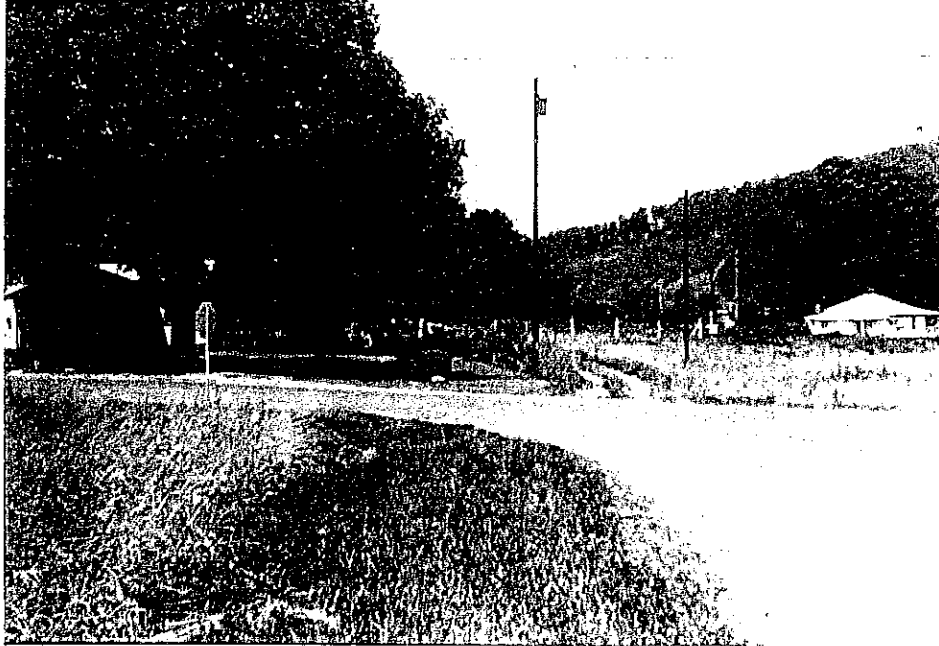
7. Houses Downstream of Dam

Two small lakes are downstream of the dam and both would probably fail in the event of a failure of Black Mountain Reservoir Dam. Further downstream there are 3 houses, a railroad track and Interstate 40 (see Photo 7). There is the potential for loss of life in the event of a failure of Black Mountain Reservoir Dam. The nearest downstream town, Black Mountain, North Carolina (pop. 3204) is approximately 2 miles below the dam.
