Subject: Structural Engineering Report – Floor loading evaluation – golf club,
Black Mountain, NC
Project Number: 209210

Project No: 209210
 Sheet No.: SK-1
 1 OF 1
 FLOOR LOADING EVALUATION
 GOLF CLUB
 BLACK MOUNTAIN
 NORTH CAROLINA
 Drawing Title:
REFERENCE PLAN

**BLACK MOUNTAIN GOLF CLUB (MULTI-USE BUILDING)
ON-SITE FIELD EVALUATION**

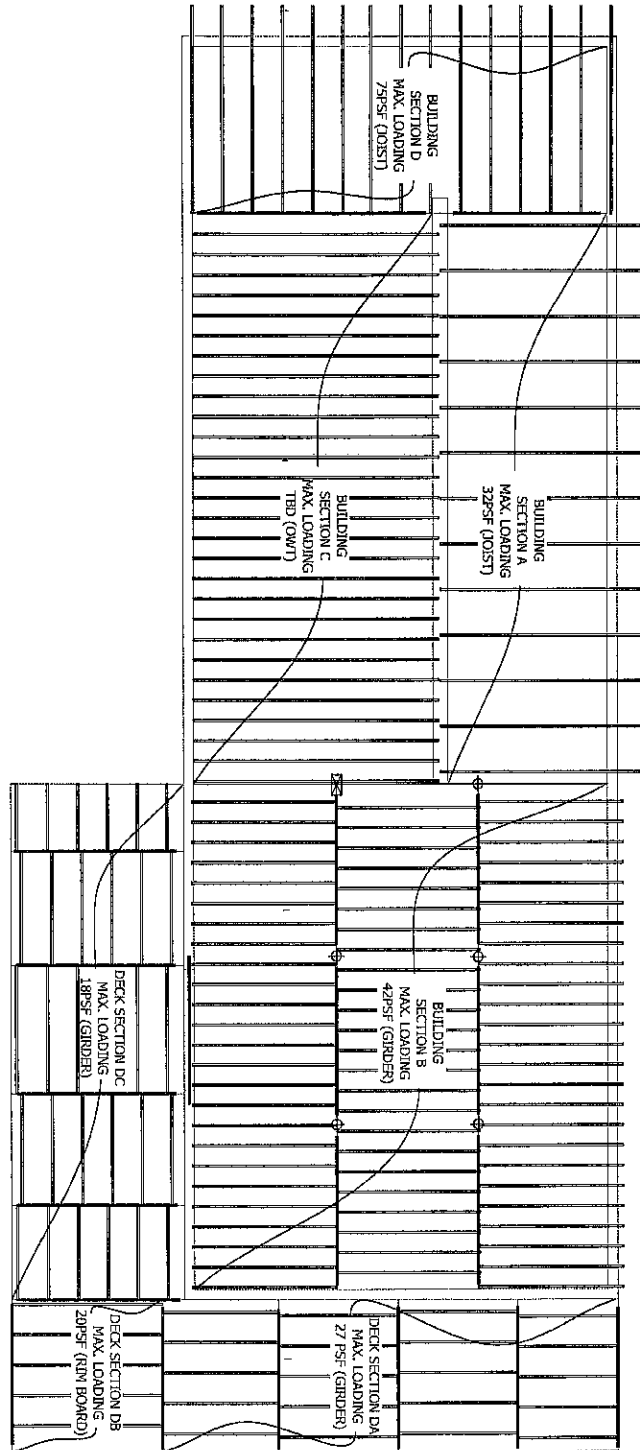
- The remainder of the main level interior floor framing systems vary in live load capacity from 32 PSF to 75 PSF. See the attached drawing for loading information and locations.

- The exterior decks are rated between 18 PSF and 27 PSF live load capacity.
- At this time, it is our opinion that the existing structure would require structural upgrades to be utilized for commercial loading values including use as a lounge, snack bar, or restaurant.

- It is our opinion that upgrades to the existing structure could be performed to bring the floor system up to a live load rating of 100 PSF. The proposed upgrades would probably require a combination of additional joists, new beams, and new columns with footings, which may limit the use of the existing basement area in the building.
